Assessment of Dam Safety

Coal Combustion Surface Impoundments (Task 3)

American Electric Power

Conesville
Generating Station

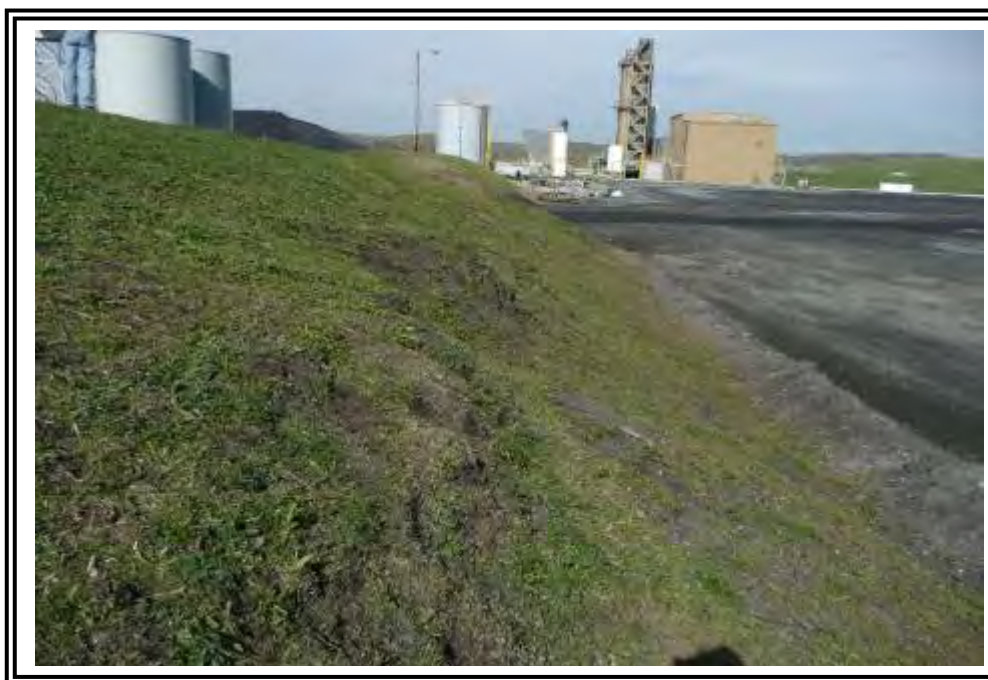
Looking northwest along upstream slope of the Southwest Dike near the northwest corner of the Bottom Ash Pond.
Note slope undulations likely resulting from past grading activities.

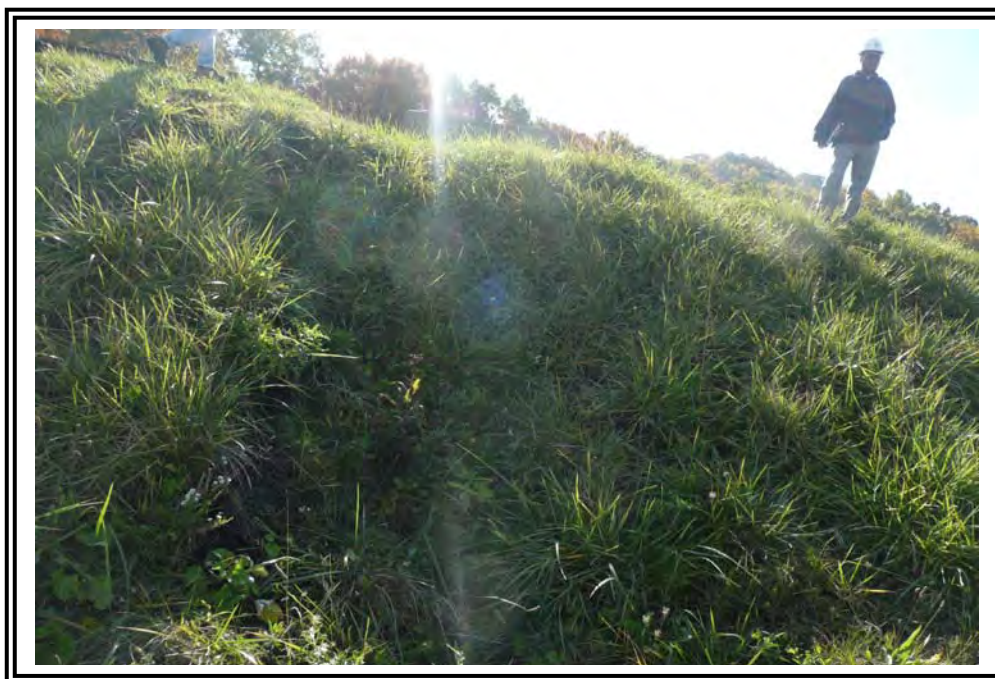
Grassed older erosion rill in upstream slope of Coal Haul Road Dike.

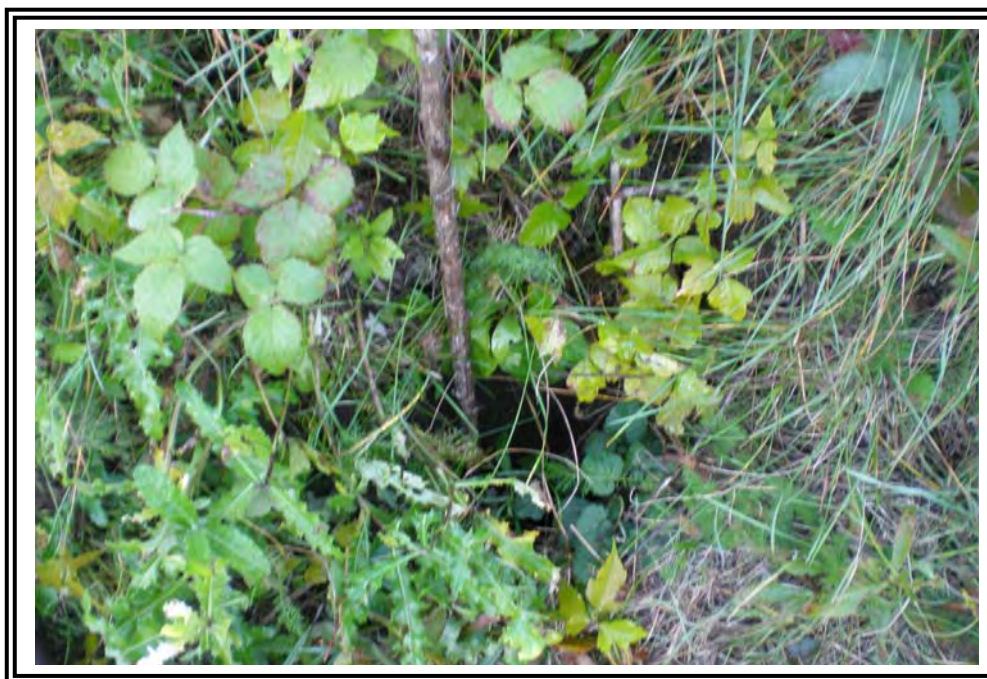
Rodent burrow on downstream slope of Coal Haul Road Dike.

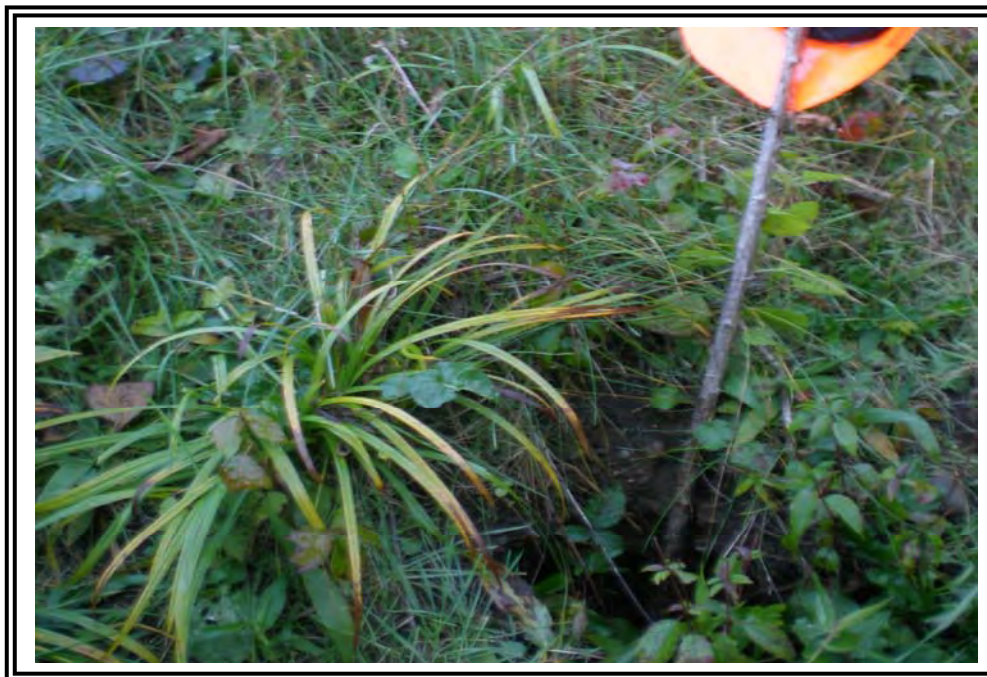
Another rodent burrow on downstream slope of Coal Haul Road Dike.

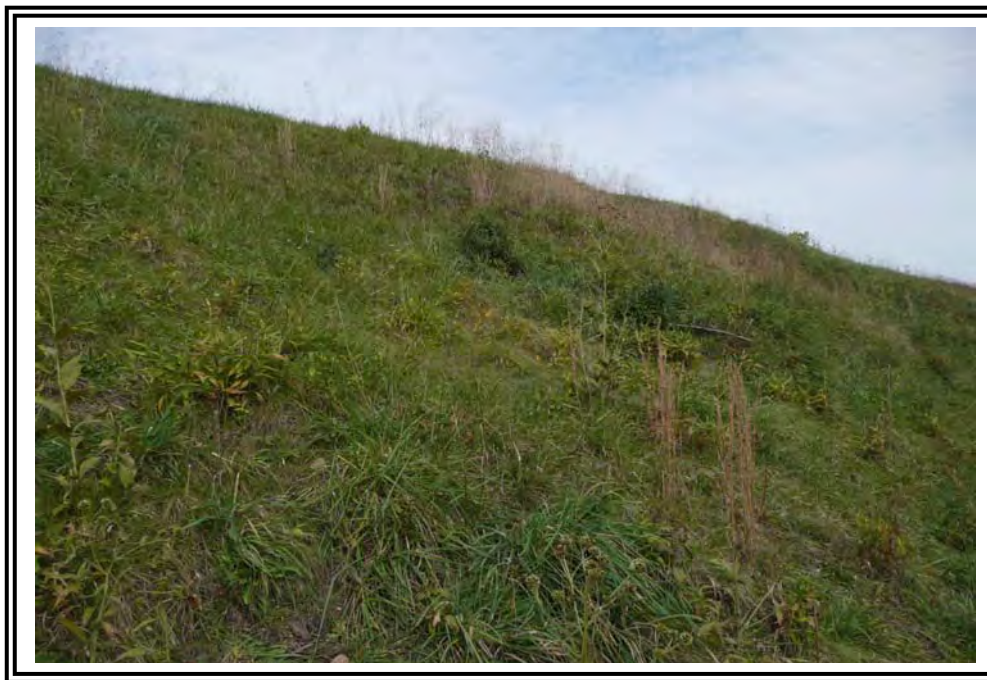
Grass covered deformation on downstream slope of Coal Haul Road Dike.

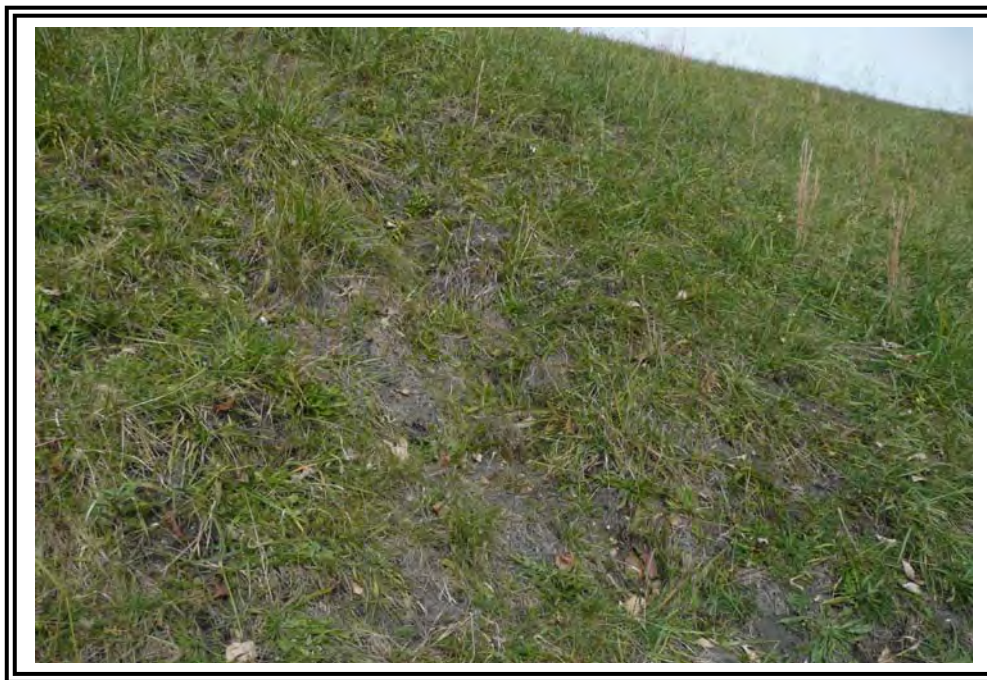
Soil and coal dust transport with intermittent grass cover loss on downstream slope of Coal Haul Road Dike.

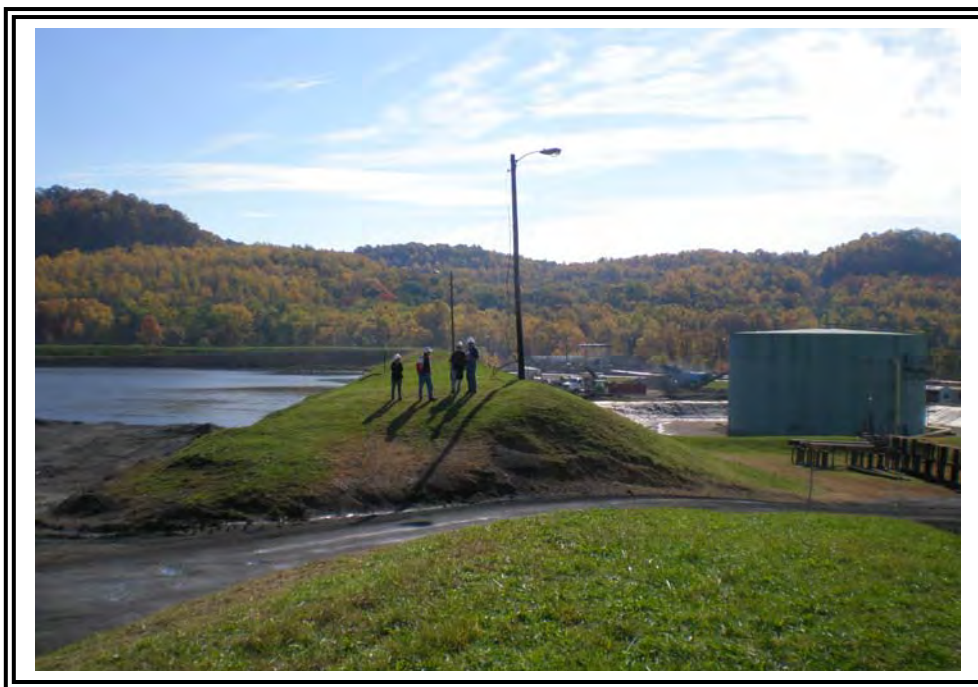
Maintenance road cut in Southwest Dike near the plant's water treatment facility, looking southeast.

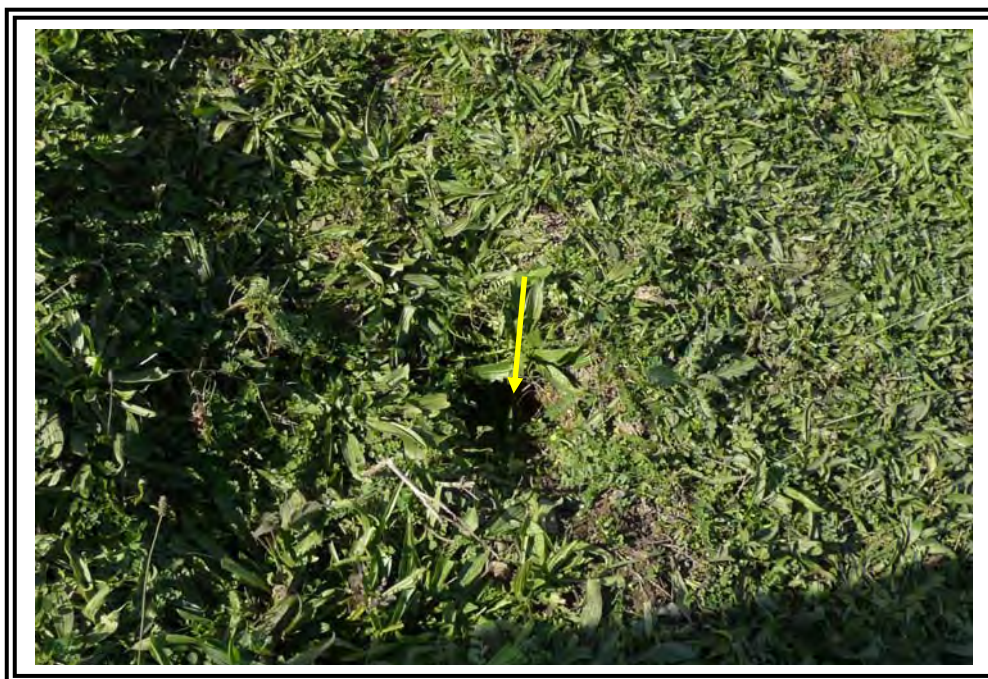
Collapsed, vegetated rodent burrow on upstream slope of Southwest Dike, likely abandoned (See arrow).

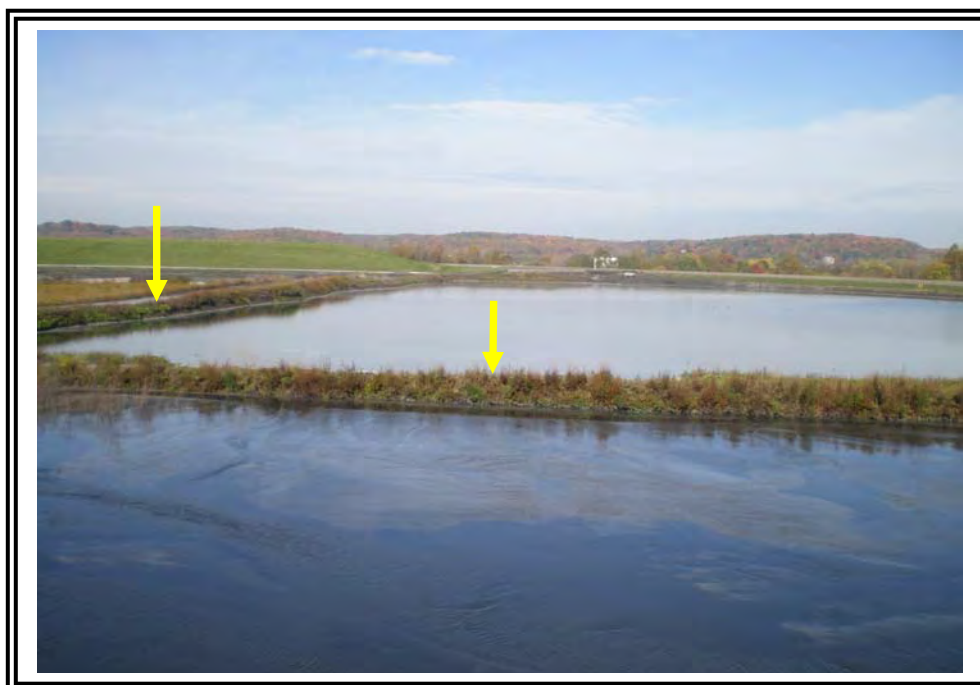
Closer view of interior divider dikes (see arrows) the Fly Ash Storage Area and Central Fly Ash Pond area.
